Hot Spot Training

Category: Tile

Hot Spot: Cracked Tile Edges

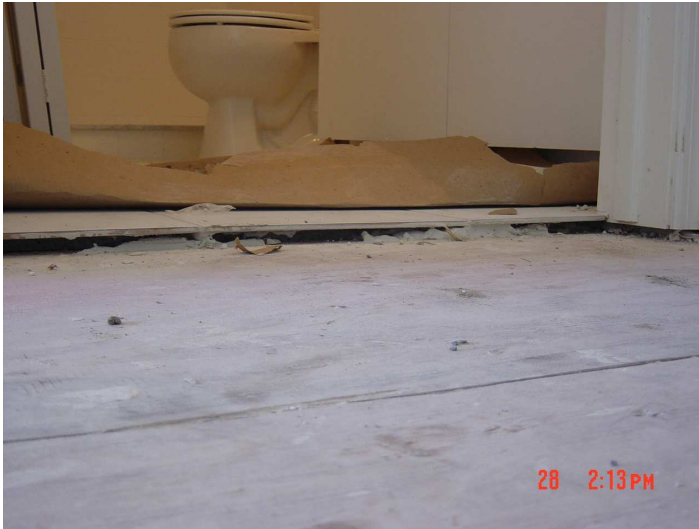
Poor Installation

- Tile edges breaking when any pressure applied
- Carpet not able to be tucked without damage occurring to the finished tile edge
- Transitions not able to be applied without causing damage to tile edge

- Hollow areas under tile edge
- Improper trowel size
- Setting material not packed to edge
- Poor attention to detail

- Remove existing transition or material meeting tile
- Remove grout and broken tile
- Scrape mastic or thinset from area
- Re-cut tile with proper equipment
- Stone edges of cut tile
- Re-install tile
- Grout and caulk all areas needed
- Reinstall new transition or material meeting tile

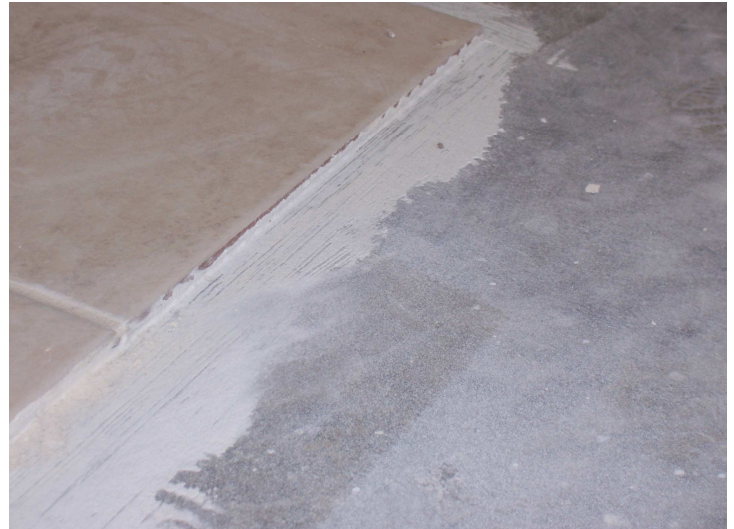
Correct Installation

- Apply setting materials full to tile edge
- Clean off any excess setting materials so the edge is square to the tile edge and floor
- Cut underlayment even with the tile edge
